# A Laser Scanning Interlaboratory Study on Selected ACI 117 Tolerance Compliance Verification

## **Objective**

- **Objective 1:** Revisit a similar procedure after six years with the hardware advancing and collect data for a precision statement following ASTM E691-23

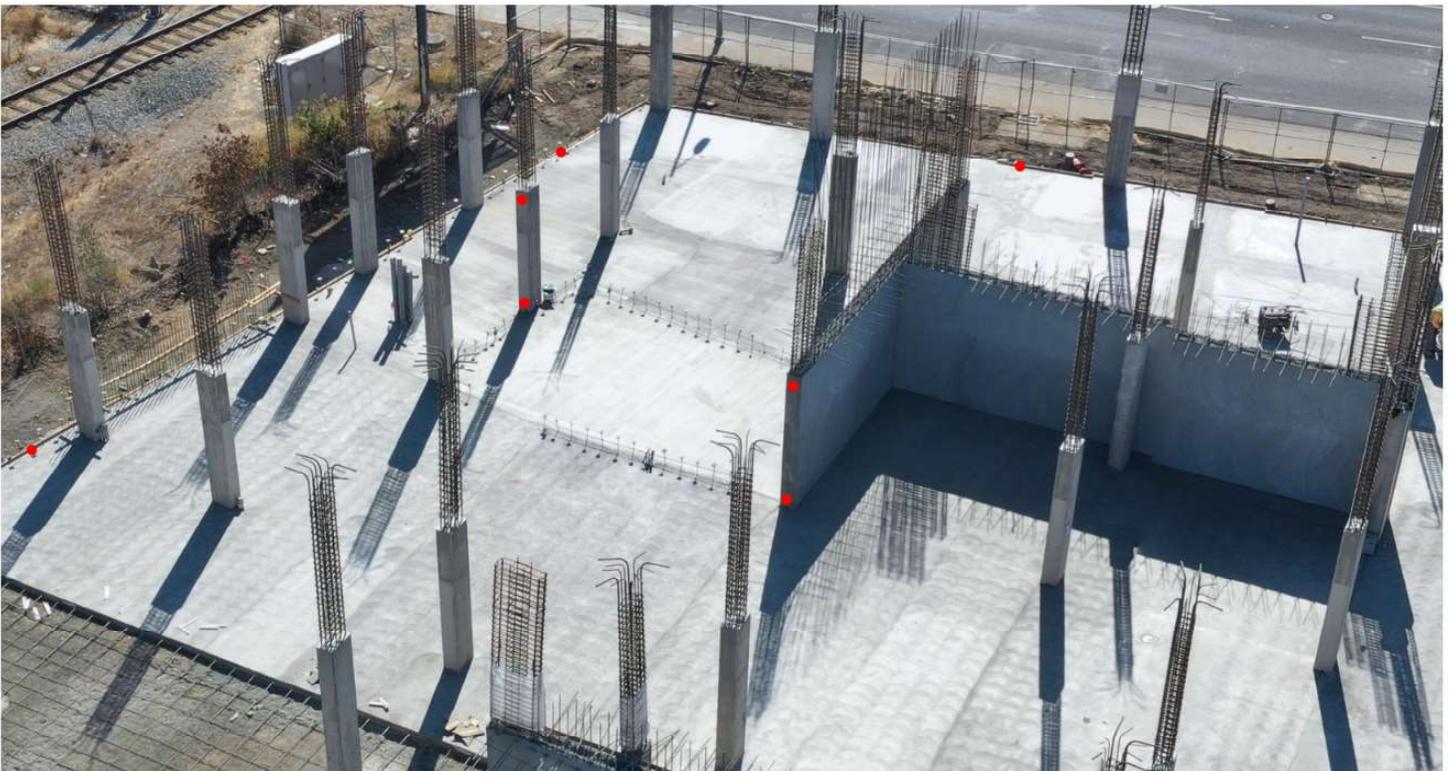
**Step 1:** Mark the test areas (10 points on slab edges, bottom of columns/walls, top of columns/walls, openings, example as shown on the photo below);
